FINAL REPORT

# Development Of Fused Slurry Silicide Coatings For Tantalum Re-Entry Heat Shields

SOLAR DIVISION OF INTERNATIONAL HARVESTER COMPANY  
SAN DIEGO, CALIFORNIA

September 1972

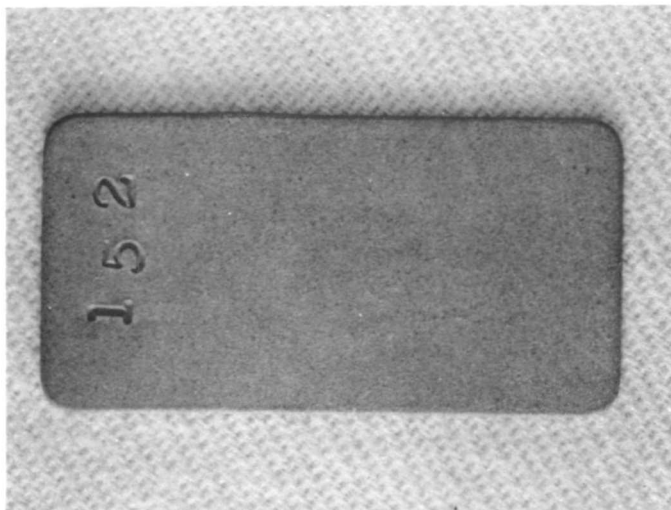
Part A

Excellent Flow

SA-3, 3600 Seconds, 1692°K

Part B

Fair Flow

SA-1, 3600 Seconds, 1692°K

Part C

No Flow

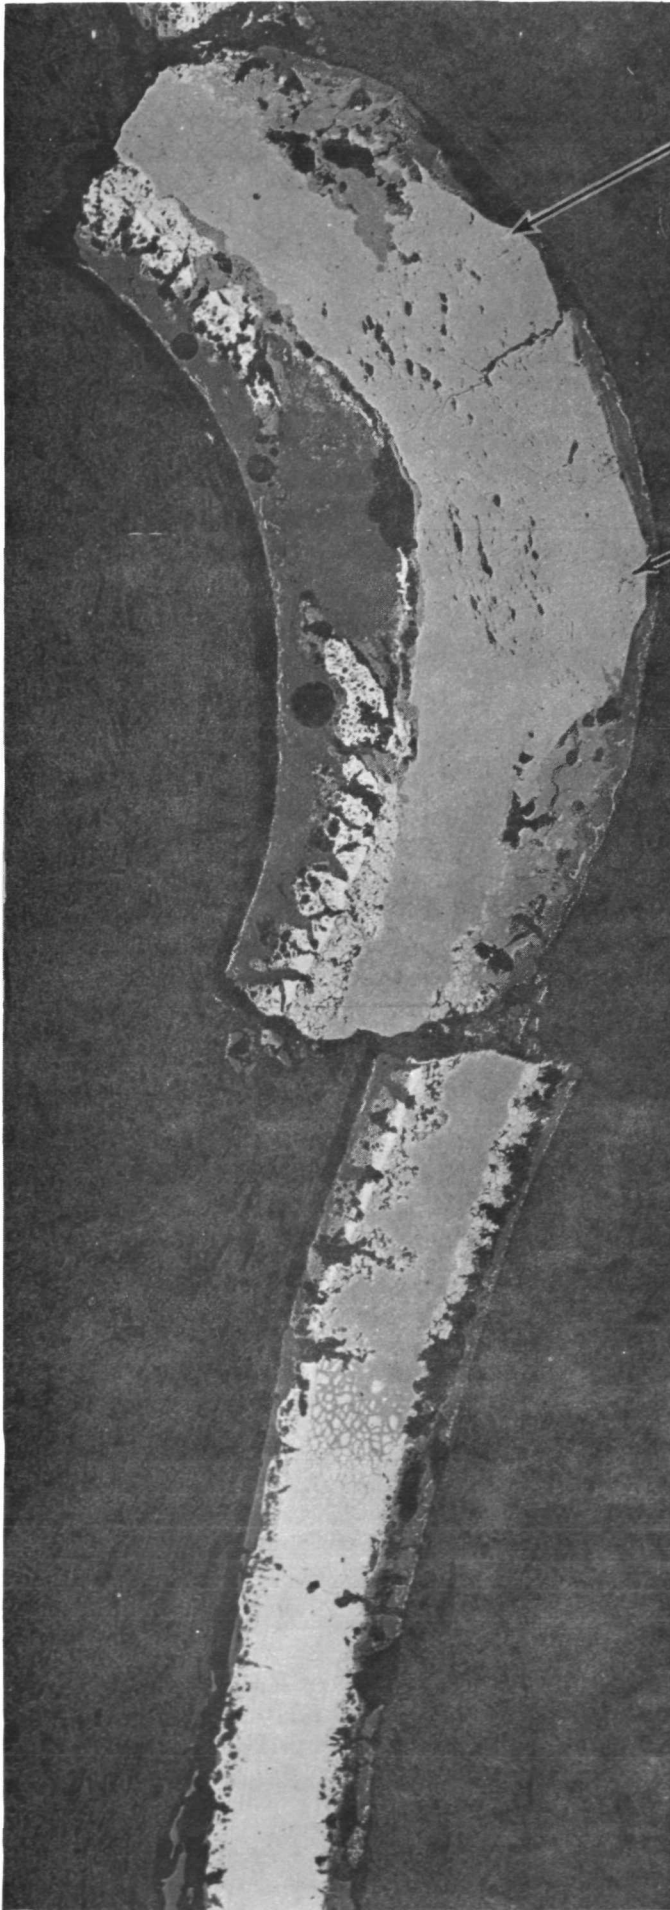
FIGURE 12. CROSS SECTION OF DAM-3 + DAS-1 INTENTIONALLY DEFECTED AREA AFTER 23 CYCLES TO 1700°K AND 1300 N/m<sup>2</sup>

Magnification: 35X

Etchant: Unetched

Intentional  
Defect,  
0.0015 m dia.

Metallographic analyses were completed on two intentionally defected and exposed specimens which did not immediately fail. Figures 12 and 13 show cross-sectional views through the defected area of a DAM-3 + DAS-1 and a DAM-7 + DAS-2 coated specimen. The lack of any silicide coating and the presence of flowed glass over the defect in the DAM-3 + DAS-1 coated specimen is evident. The extent of the obviously affected substrate zone (under DAM-3 + DAS-1) was determined to be a circle, approximately concentric about the defect and of about 0.0035 meter diameter. No glass is apparent in the defected area of the DAM-7 + DAS-2 coated specimen. The obviously affected substrate zone measured about 0.0055 meter in diameter for this specimen.

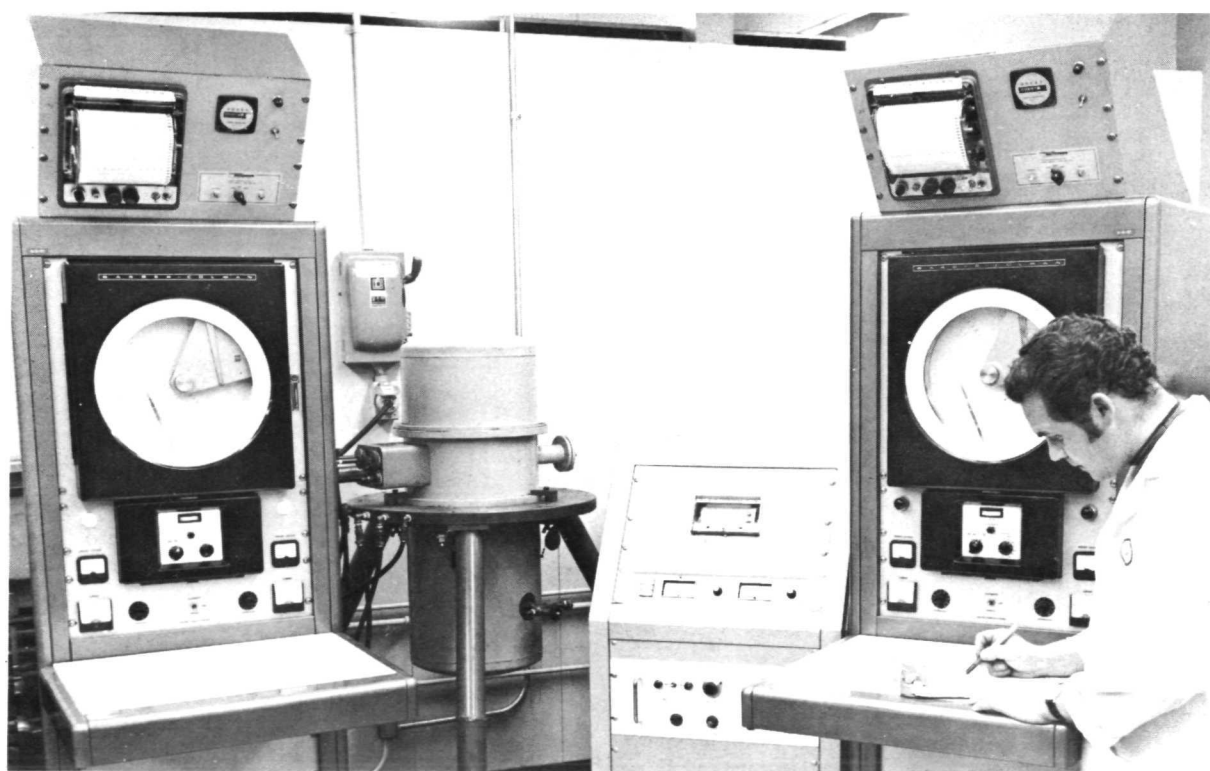
FIGURE 66. RE-ENTRY SIMULATOR

Re-entry simulation for the coated miniature heat shield panels consisted of simultaneously exposing the specimens to a controlled temperature, air pressure and stress as a function of time. Tests were performed in one of Solar's re-entry simulators especially modified to accept the 1- x 4-inch MHS panels. Figure 66 shows an overall view of the test rig, and Figures 67 and 68 provide detailed views of the heating system and the stressing mechanism.

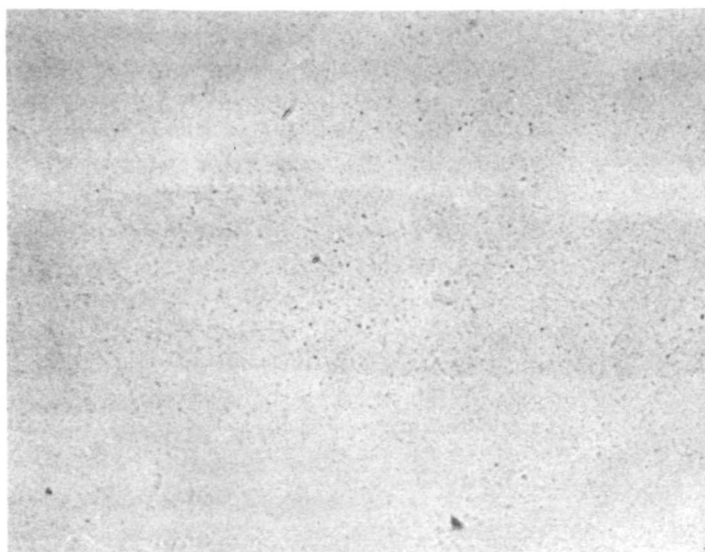
MHS Panel Joint

FIGURE 72. MICROSTRUCTURE OF CSDB JOINT IN MHS PANEL

Ribs were fabricated from 0.013-inch rather than 0.020-inch thick 90Ta-10W alloy for this program. A completed panel is shown in Figure 71, and the typical CSDB joint appearance is shown in Figure 72. The darker, central area is the tantalum inter-leaf used as an aid in bonding. No evidence for unbonded areas or "dirty" interfaces was indicated by the metallography.

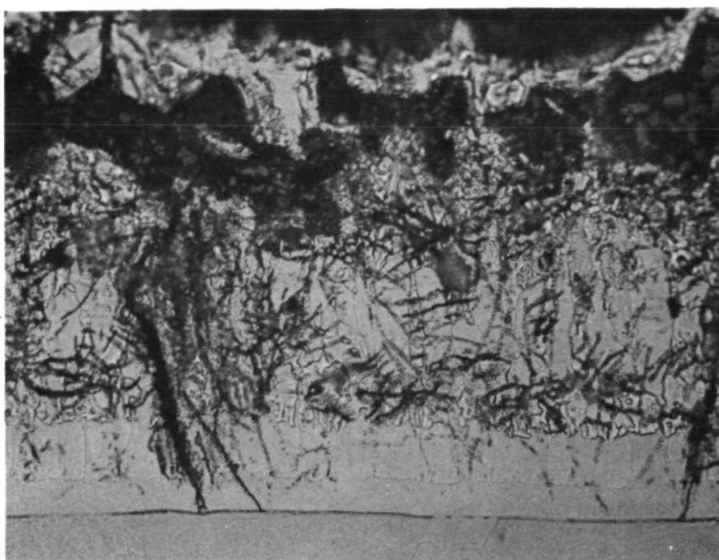
Outer Surface, Facesheet, 0.0064  
Meter From End of Panel

286-323 KHN (100 g load)

Outer Surface, Facesheet, Center  
of Panel

FIGURE 78. SA-13 MICROSTRUCTURE MHS PANEL "D", AFTER 48 RE-ENTRY  
CYCLES TO 1700°K AND EXTERNAL PRESSURE

A detailed view of the re-entry exposed coating is shown in Figure 78 together with substrate centerline hardness measurements. Coating consumption was possibly greater near the center of the panel than at the ends. The range of hardness values includes six individual data points spaced across the width of the facesheet. No obviously oxidized areas were present on either specimen in Figure 78. The wide range of hardness values measured at the midpoint of the panel presumably reflects the possibly greater coating consumption observed in this area and the effects of stress.

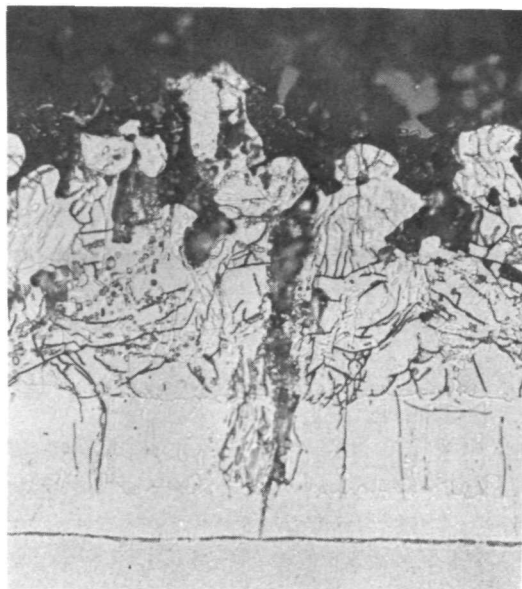
FIGURE 87. SA-13 + GN-19D MICROSTRUCTURE, MHS PANEL "K", AFTER 58 RE-ENTRY CYCLES TO 1700°K AND INTERNAL PRESSURE

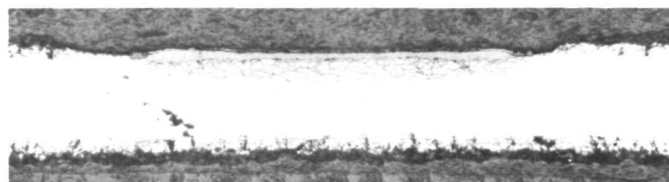
SA-13 + GN-19D, 13 N/m<sup>2</sup>

SA-13 + GN-19D, 1300 N/m<sup>2</sup>

FIGURE 92. MACRO AND MICROSCOPIC APPEARANCE OF 4T SPOT DEFECTED SPECIMENS AFTER 1 LP-SC TO 1700°K

An example of the surface and cross-sectional appearance of intentionally introduced, 4T spot defects is shown by Figure 92. Each specimen shown in this figure was exposed for one LP-SC at 1700° K. Exposure for one LP-SC at 1810° K and 1300 N/m<sup>2</sup> caused considerable damage and distortion in both SA-13 and SA-13 + GN-19D overlaid coupons. The SA-13 coated samples burned through at the defect; the GN-19D overlaid ones did not. Closer examination of glass overlaid coupons showed (Fig. 93) that the glass had definitely flowed or diffused across the defect and thereby provided a measure of protection to the substrate. Figure 93 shows the edge of an intentional defect and the continuous layer of glass which covered the entire defect after test.

A diagram of substrate microhardness vs distance from the defect is shown by Figure 94 for each specimen shown in Figure 92. Microhardness measurements (KHN, 100 g) were made every  $250 \times 10^{-6}$  meter and are shown to scale with respect to the original defect size. These data support the optical data (Fig. 93) which showed that GN-19D overlaid coupons were better able to resist defects than were plain SA-13 coated samples. The advantage of having the glass overlay appears less clearcut at 13 than at 1300 N/m<sup>2</sup>.

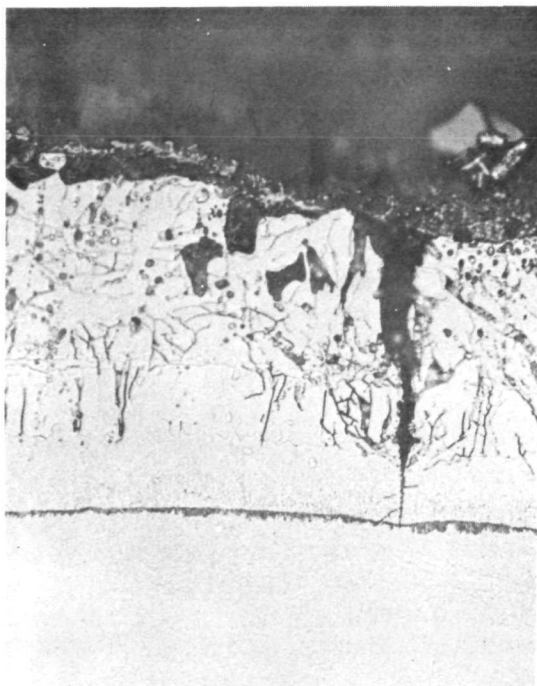
Spec. No. 308

28 LP-SC

Substrate  $\bar{C}_L$  Hardness = 259-  
286 KHN (100 g)

Spec. No. 263

100 LP-SC

FIGURE 95. SA-13 + GN-19D MICROSTRUCTURE AFTER LP-SC EXPOSURE  
AT 1700°K AND 1300 N/m<sup>2</sup>

Examples of 1700° K - 1300 N/m<sup>2</sup> LP-SC tested, GN-19D overlaid coupons are shown in Figure 95 after 28 and 100 cycles. Comparison with specimens exposed at

13  $\text{N/m}^2$  (Fig. 42) suggests a lower rate of silicide consumption (fewer voids) for 1300 than for 13  $\text{N/m}^2$  exposure. Appearance of the GN-19D overlaid coating is shown in Figure 96 after  $1810^{\circ}\text{K}$  - 1300  $\text{N/m}^2$  exposure. Considerable glass fluidity is evident from the very smooth outer surface.

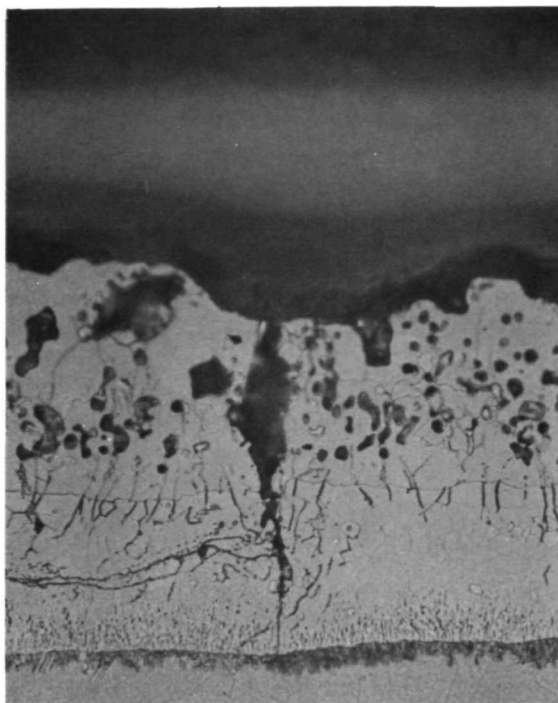
Specimen No. 295

30 LP-SC

Magnification: 500X

FIGURE 96. SA-13 + GN-19D MICROSTRUCTURE AFTER LP-SC EXPOSURE AT 1810°K - 1300 N/m<sup>2</sup>
